22-INCHES OF FOUNDATION SETTLEMENT RECOVERED WITH **Atlas Piers™!**

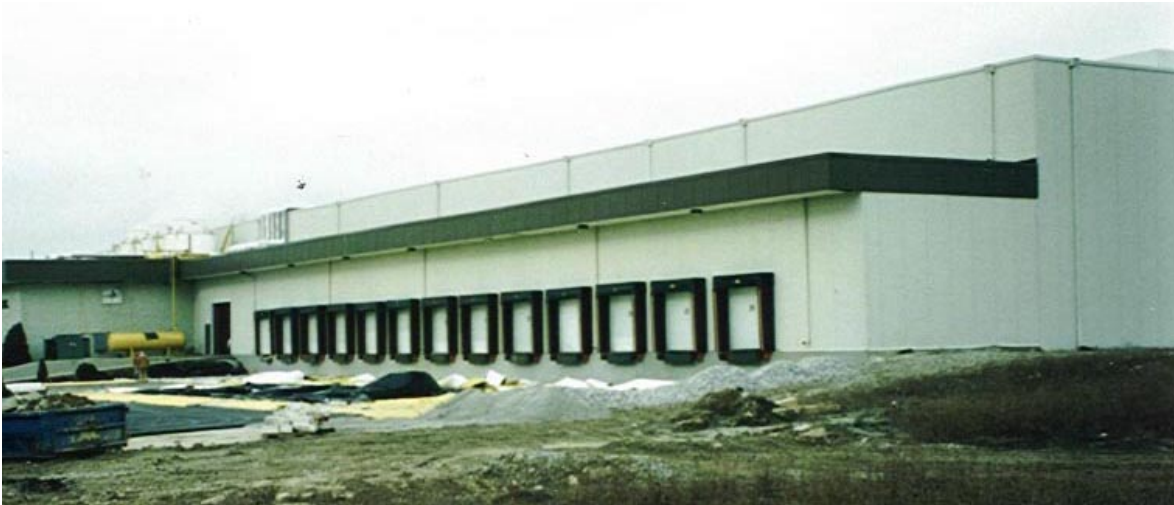
This is a view of the front of the structure. The loading dock shown here had settled 8 inches. Some areas at the right side of this building suffered settlement in excess of 22 inches!

The management and maintenance department of the company chose **Atlas Continuous Lift Resistance Piers** to solve the settlement and structural instability problems. Elevation measurements made prior to restoration revealed that the foundation settlement was 8 inches at the dock area and in excess of 22 inches along the side of the structure!

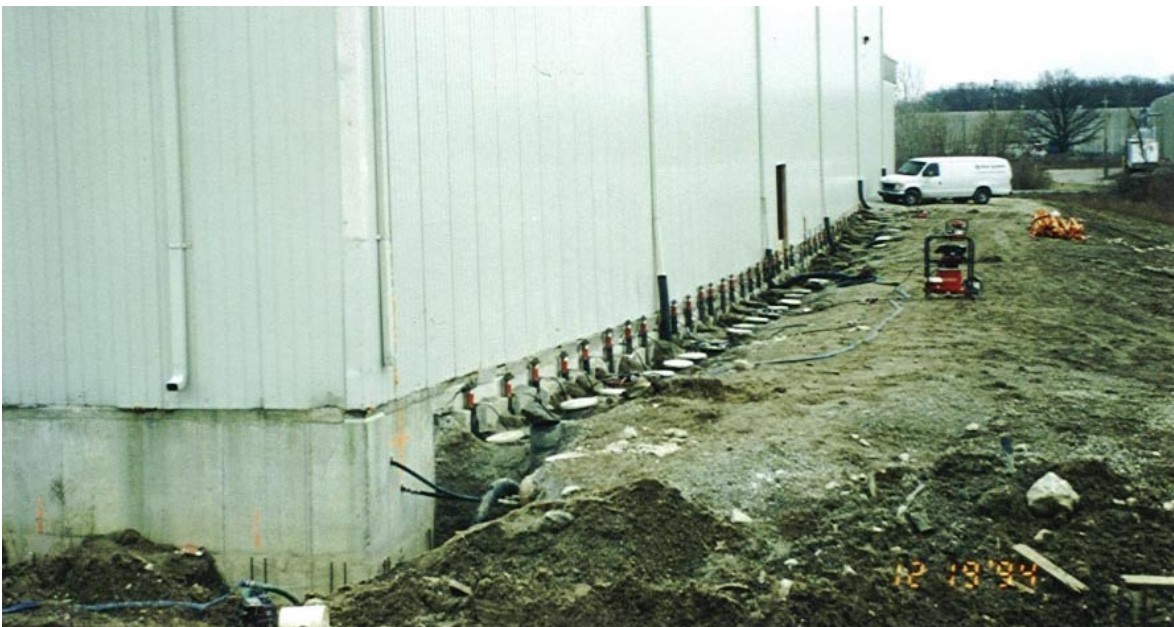
The photo above shows the right side being carefully and gently lifted. Note the hydraulic rams on each pier.

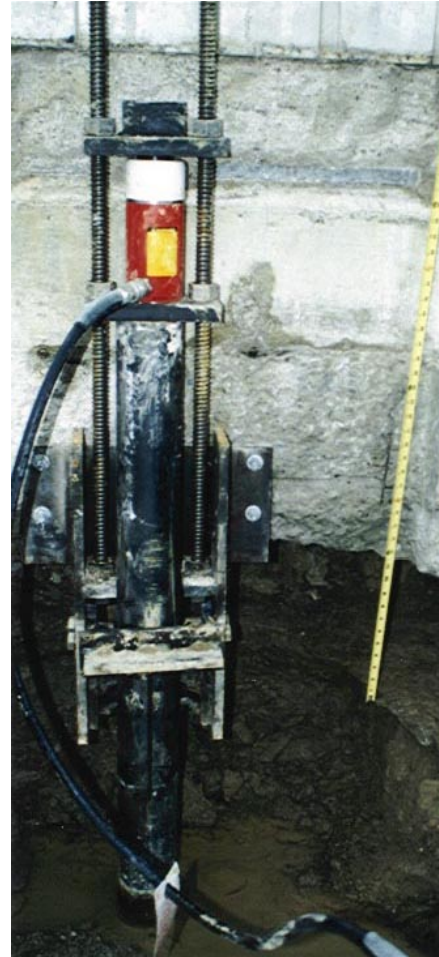
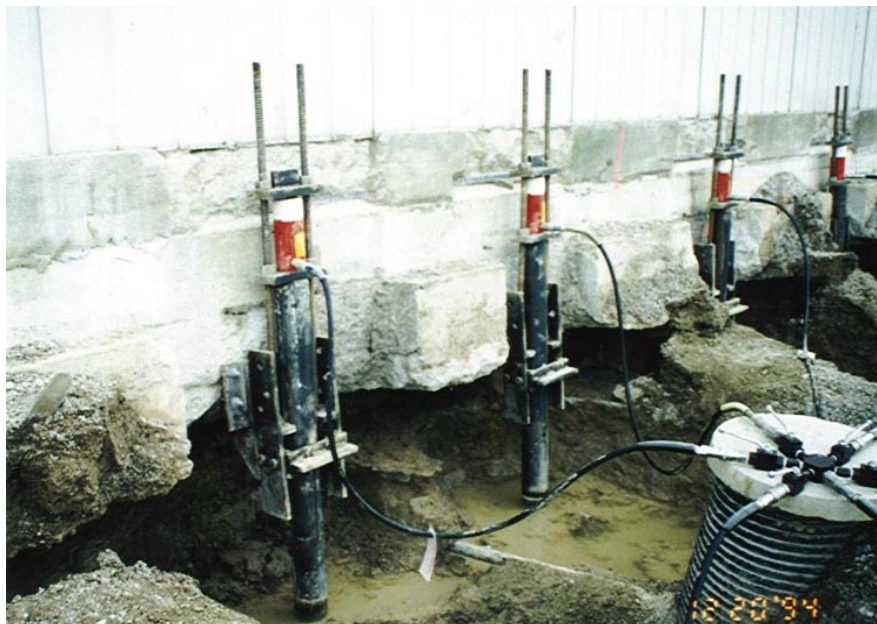
The photographs show the restoration process using **Atlas Continuous Lift Resistance Piers**. The recovery at this point is approximately fifty percent. The tape measure above shows a lift of approximately 11 inches.

Notice how the piers were all connected together by manifolds. Each hydraulic ram was actuated at the same time to provide a gentle, even lift.

A load-bearing stratum was located at an average depth of 50 feet below the surface. The soil analysis reported that the soft organic material extended to a depth of 18 feet under parts of the structure. There was concern that the weak soil below the building may not provide adequate lateral support to the pier. To increase the moment of inertia (stiffness) of the piers in this weak material, four-inch diameter sleeves were installed over the pier pipes to a depth of 21 feet. The sleeve joints were staggered with the pier pipe couplings to enhance the strength of the couplings and the pier.
